Project: 0013091150

Subject: Crusher Road Slope Instability – Observation Update

CRUSHER ROAD SLOPE
INSTABILITY
Leviathan Mine Site
Alpine County, California

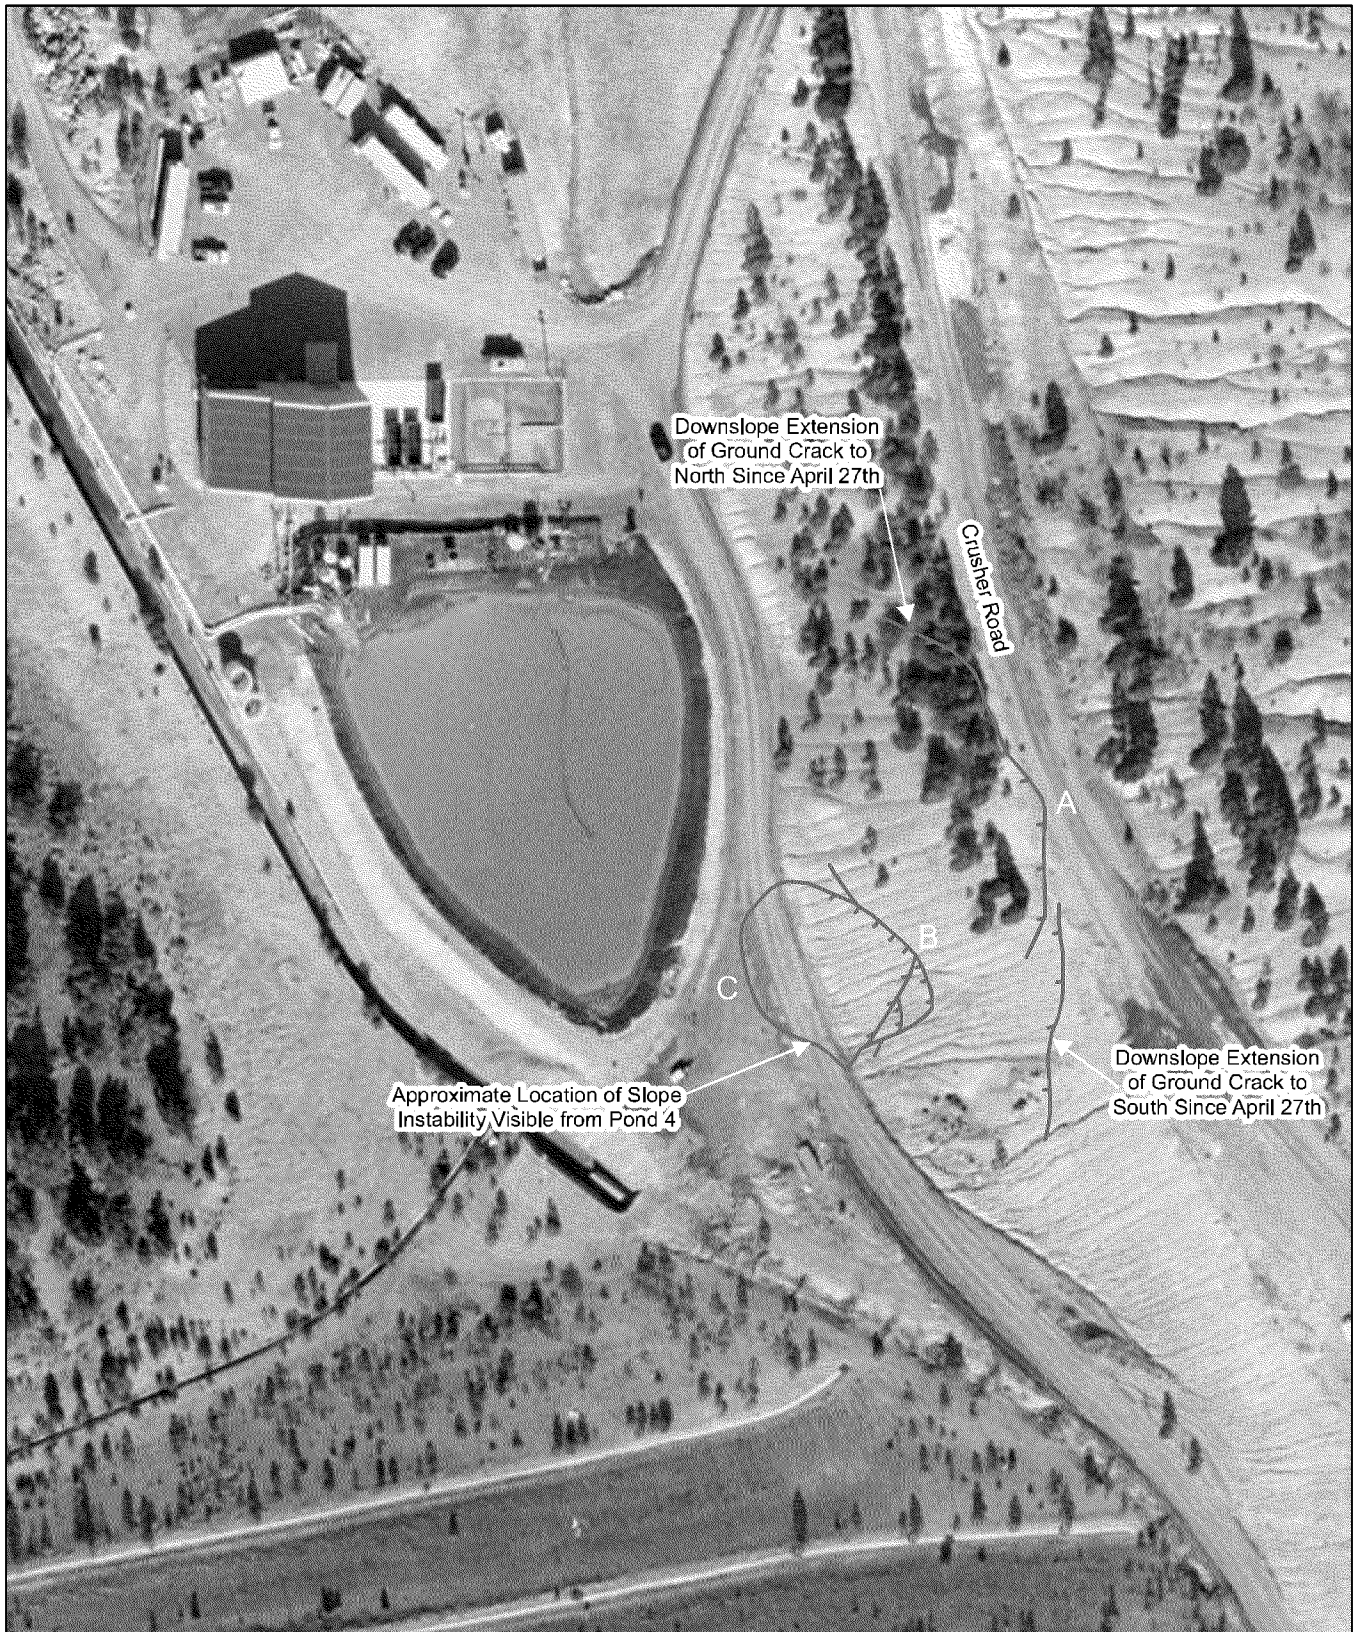
Figure
1

On initial inspection on April 27, 2017, the ground crack at the top of the Crusher Road slope (Labelled "A" on Figure 1) was observed to be approximately 200 feet long, and up to 1 to 3 inches wide with 1 to 2 inches of vertical offset (slope side of the ground crack down dropped relative to the Crusher Road side of the crack). The crack was restricted to the berm area along the crest of Crusher Road slope. Visual observations over the last two weeks indicate this feature has been creeping since initial discovery. On May 12, 2017, 15 days after discovery, this ground crack had increased in length and had more pronounced aperture and vertical offset. The north and south ends of the ground crack at the Crusher Road slope crest were observed to extend approximately 30 feet down slope and 40 feet down the slope, respectively. The ground crack along the slope crest was up to 5 inches wide with up to approximately 12 inches of vertical offset. Additional ground cracks approximately ½ to 1 - inch wide were also encountered up to half way across the Crusher Road.

On initial inspection on April 27, 2017, the approximately 80-foot-long arcuate scarp in the bottom half of the Crusher Road slope (labelled "B" on Figure 1) was observed to have up to 6-inches of vertical offset. The south end of scarp extended to the toe of slope, while the north

end of the scarp terminated on the slope approximately 15 feet up from the toe. Active seepage was noted at the toe of slope, and evidence of previous seepage was observed in several spots on the slope at the northern terminus of the scarp, approximately 15 feet up from the toe of the slope. Visual observations over the last two weeks indicate this feature has been creeping since initial discovery. On May 12, 2017, approximately 15 days after discovery, the scarp had increased in height to approximately 5 feet, and the northern end of the scarp had extended down to the toe of the slope. A visible bulge in the California access road with up to 4 feet of vertical rise was noted, including a well-defined toe (labelled "C" on Figure 1) riding out over the existing roadway with 6 inches to 1 foot of vertical offset. Continued seepage was noted along the toe of the slope.

Amec Foster Wheeler is preparing a surface movement monitoring program intended to support the assessment of surface conditions with regards to potential hazards to site personnel associated with the Crusher Road Slope Instability. The proposed monitoring will generally consist of observations, measurements, and photographic documentation of ground deformation features, water seepage, surface water flow, surface water ponding, scarp height and width, groundwater levels, and the physical condition of Pond 4. Atlantic Richfield will review its plans with the Water Board before for installing any measuring devices or other equipment on or near the Crusher Road slope.

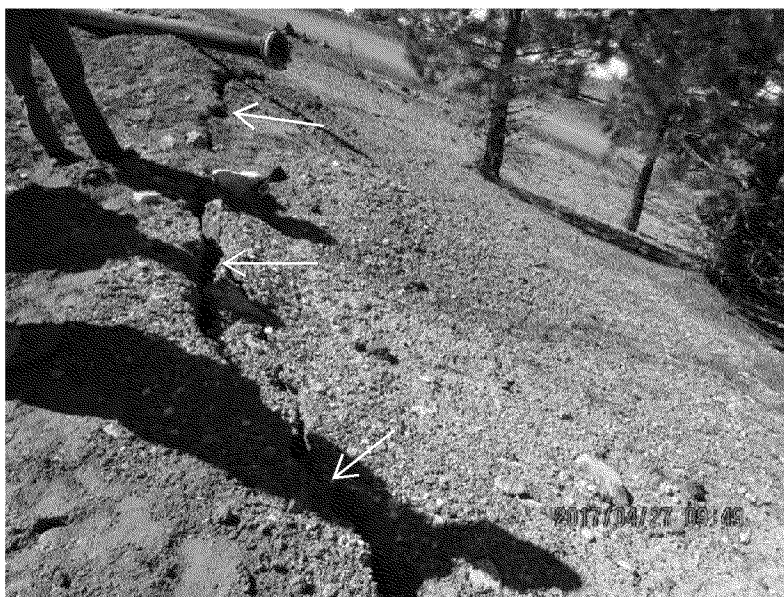
Photograph 1 April 27, 2017. Southern end of ground cracking at top of Crusher Road Slope. View looking southwest

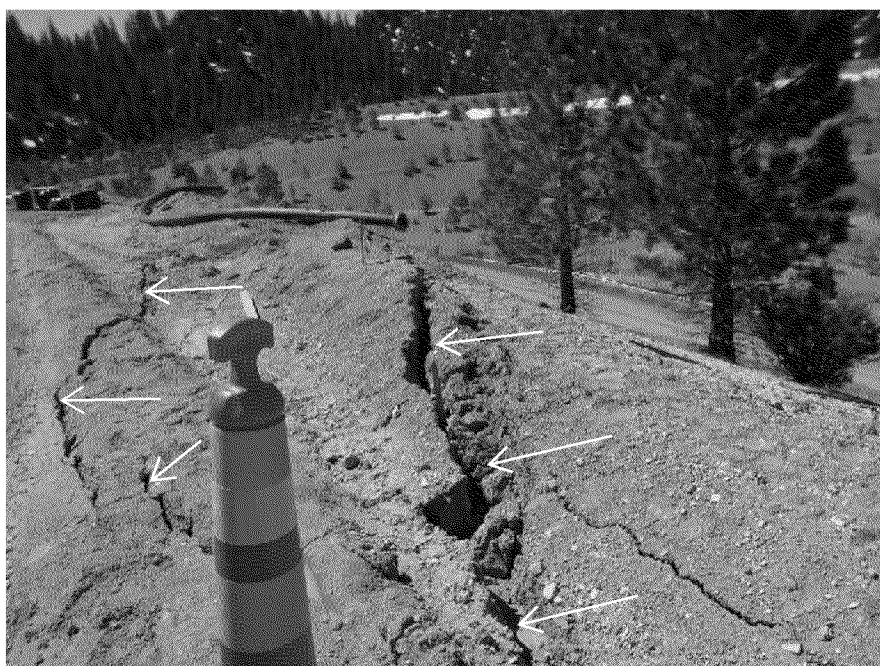
Photograph 2 May 11, 2017. Southern end of ground cracking at top of Crusher Road Slope. View looking southwest

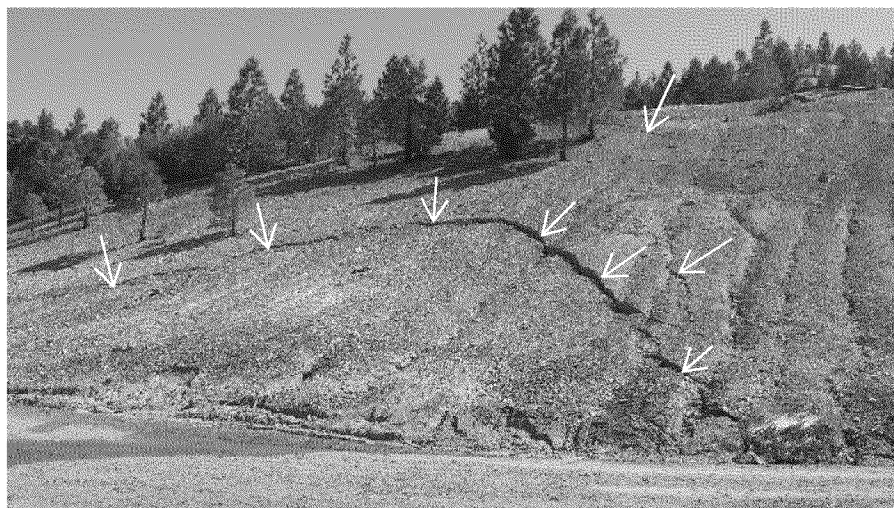
Photograph 3 April 28, 2017 Instability in lower half of Crusher Road slope. View looking northeast

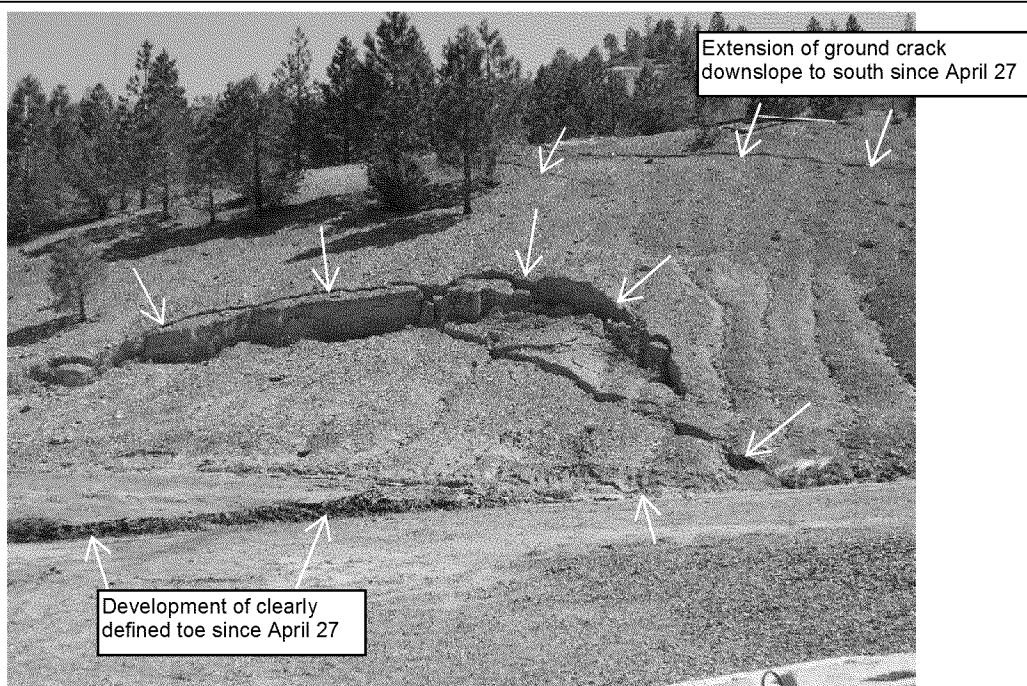
Photograph 4 May 11, 2017 Instability in lower half of Crusher Road slope. View looking northeast
